Subject: August 31, 2006, Compliance Evaluation Inspection - Asarco East Helena Plant

FIELD INVESTIGATION REPORT

SITE: Asarco - East Helena Plant

PURPOSE: Compliance Evaluation Inspection

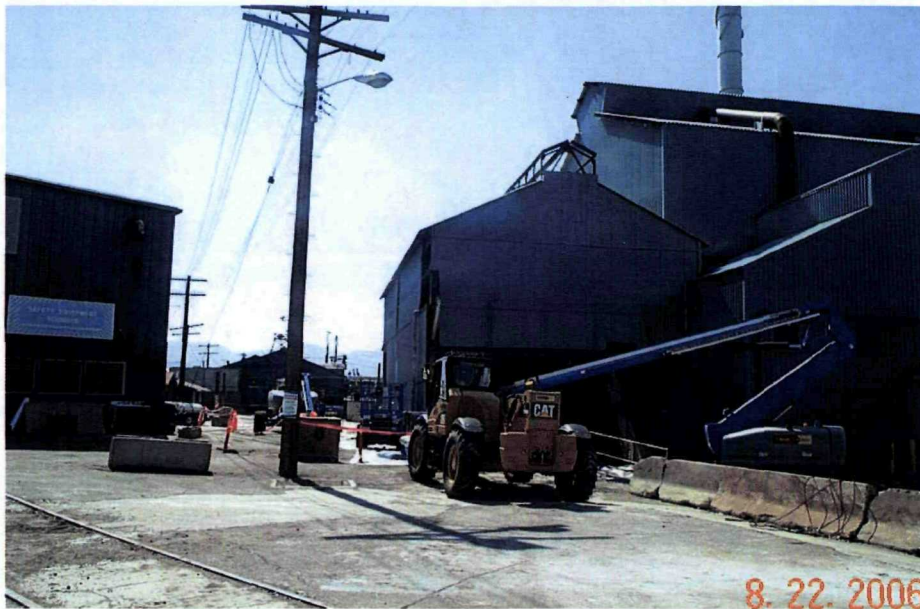
I observed that the demolition contractor had completed the dismantling of the bullion casting building at the time of the inspection. In addition, several exterior panels from the west and south walls of the Dross Plant had been removed. Some of the panels, which are destined for metal recycling, were stacked in an adjacent area to the south of the building. There was evidence that some hazardous waste material had been cleaned up in the Dross Plant and taken to the Bailey building for future disposal. (See photos #001, 002, 003, 004, 005 and 006 in the attached photolog).

This photo shows the beginning stages of Phase II demo of the bullion casting and dross buildings on August 22, 2006.

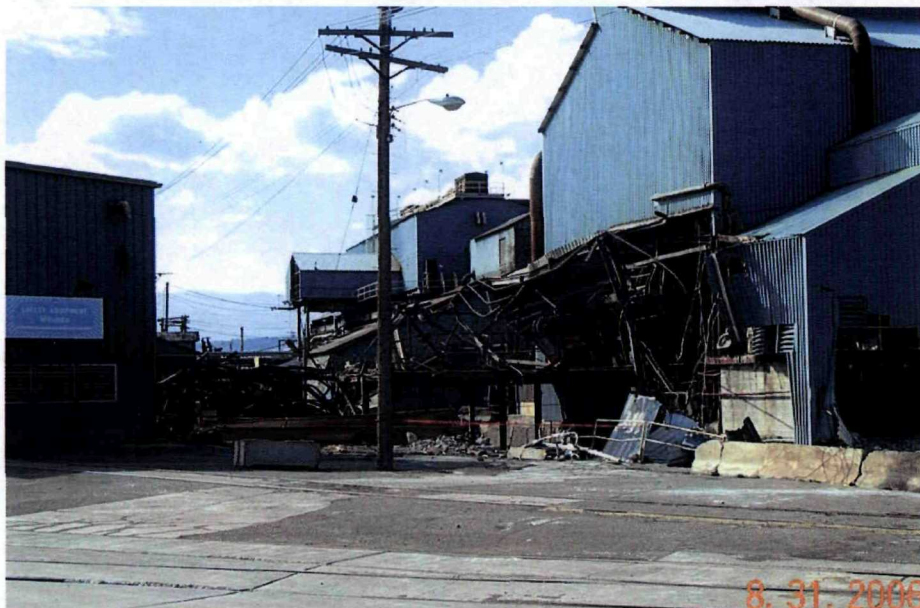
PHOTO #: ASARCO_06243-002
PHOTOGRAPHER: Iver L. Johnson
PHOTOGRAPHER (int.) *Iver L. Johnson*
CAMERA: Kodak DC5000 Zoom Digital Camera
FILM TYPE: N/A
NEGATIVE LOCATION: N/A
EXPLANATION:

This photo shows the same building, as in photo #001, nine days later.

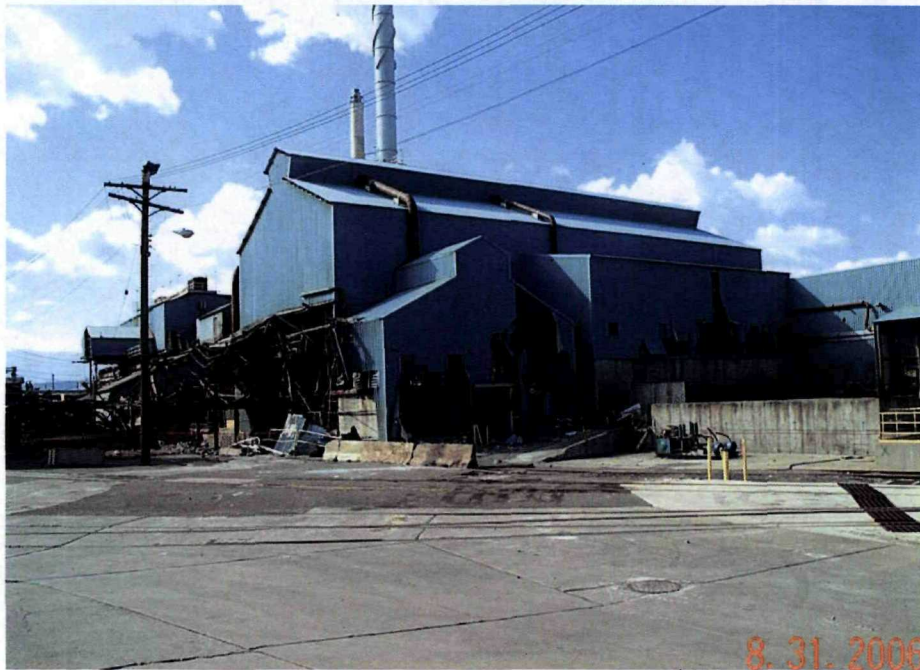
PHOTO #: ASARCO_06243-003
PHOTOGRAPHER: Iver L. Johnson
PHOTOGRAPHER (int.) *Iver L. Johnson*
CAMERA: Kodak DC5000 Zoom Digital Camera
FILM TYPE: N/A
NEGATIVE LOCATION: N/A
EXPLANATION:

Looking at a bigger picture of the bullion casting and Dross Plant in the beginning stages of demolition.

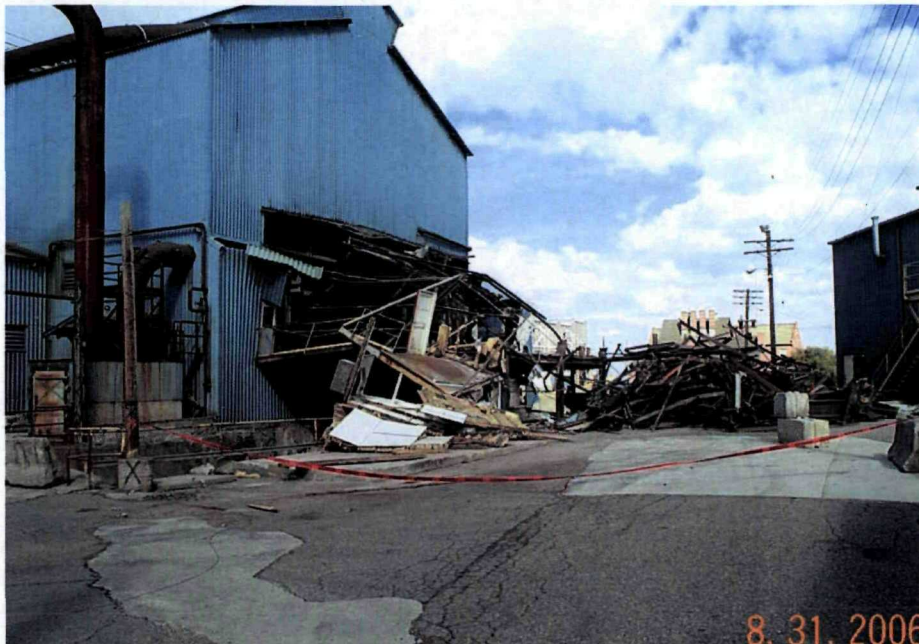
PHOTO #: ASARCO_06243-004

Looking at another view of the demolition of the bullion casting building.

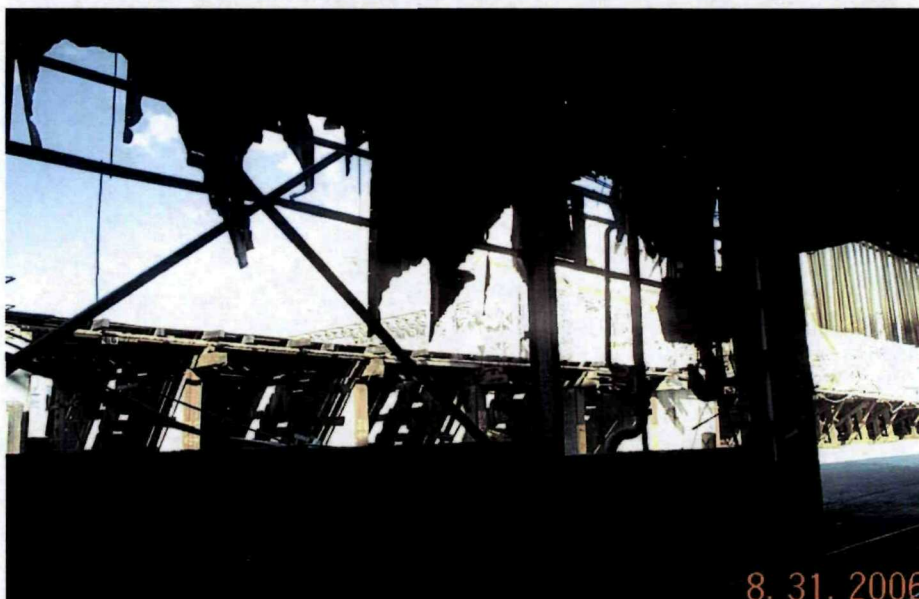
PHOTO #: ASARCO_06243-005

Standing inside the Dross Plant, this photo shows the removal of the paneling on the south side of the plant. The paneling can be recycled as scrap metal.

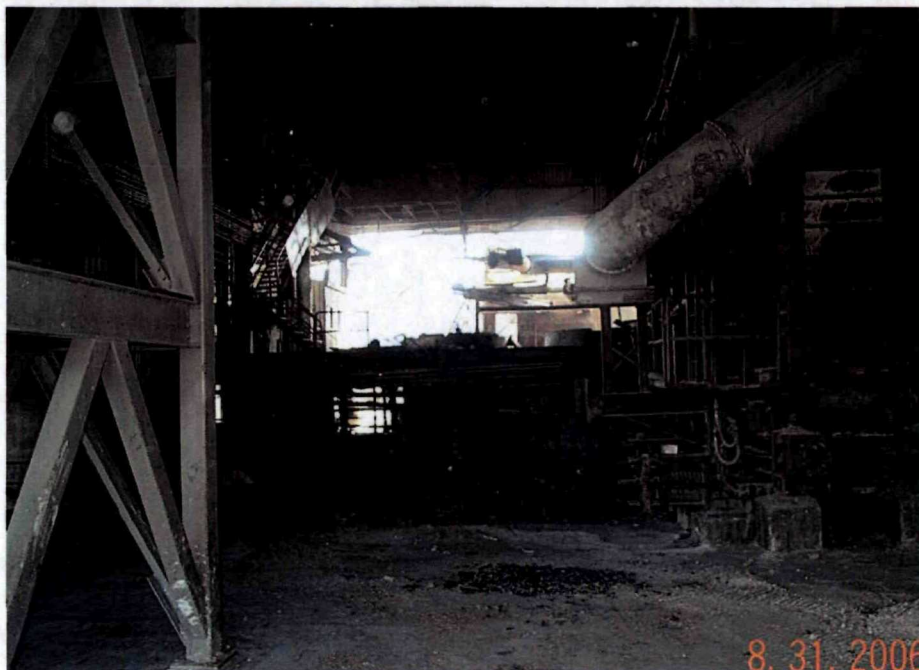
PHOTO #: ASARCO_06243-006

Another view from inside the Dross Plant. looking north to the bullion casting building demolition.

Note the dross reverb furnace and associated duct work to the right of the photo.

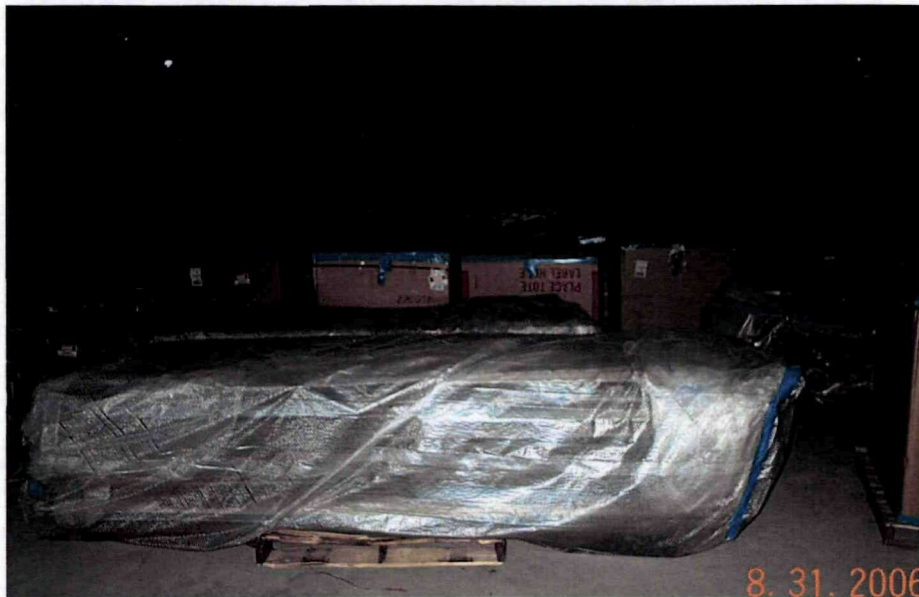
PHOTO #: ASARCO_06243-007

I inspected the Asbestos Containing Material (ACM) storage area in the Direct Smelt building. ACM that was stored in the Bailey building has now been re-located into this building. No RCRA or Asbestos violations were observed here at the time of the inspection. (See photo #007 in the attached photolog).

Looking an ACM stored in the Direct Smelt building that was re-located from the Bailey building.

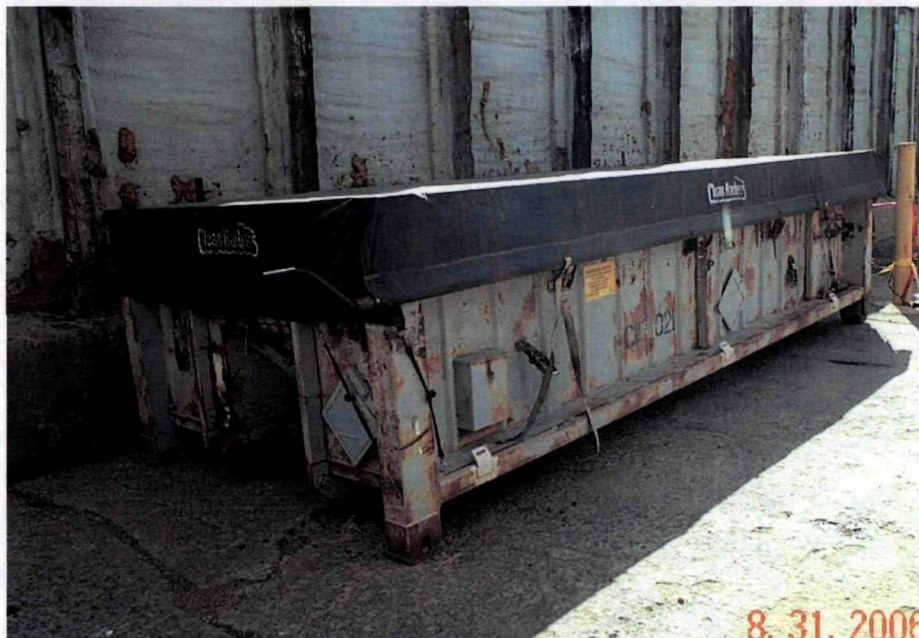
PHOTO #: ASARCO_06243-008

A 20-yard roll-off containing High Density Sludge (HDS) was stored just outside the entrance into the Direct Smelt building. The container was properly covered and marked with a yellow hazardous waste label. The label bore an accumulation start date of August 24, 2006. (See photos #008 and 009 in the attached photolog).

Located just outside the Direct Smelt building entrance a 20-yard roll-off containing High Density Sludge (HDS) was awaiting disposal. It was properly covered and marked with a yellow hazardous waste label.

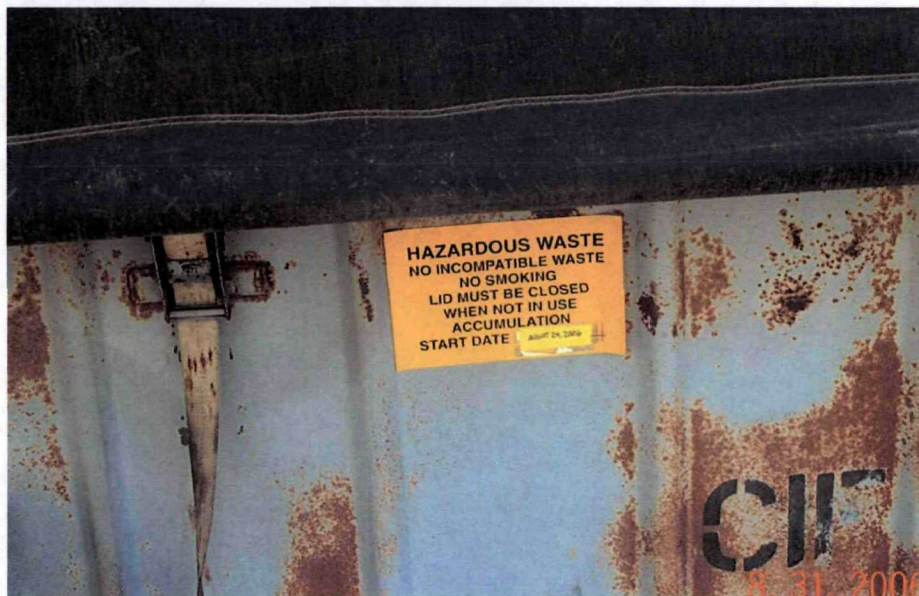
PHOTO #: ASARCO_06243-009

The yellow hazardous label on the 20-yard roll-off bore an accumulation start date of August 24, 2006.

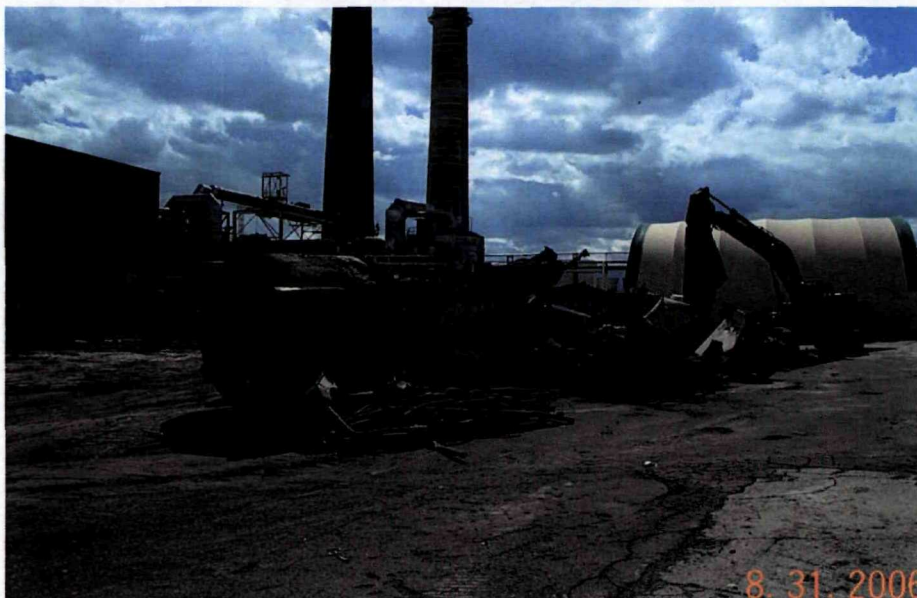
PHOTO #: ASARCO_06243-010

As the inspection team was making its way across the facility grounds to the Bailey building, I observed that the demolition contractors were in the process of tearing down the acid plant scrubbers and associated support towers and duct work.

At the time of the inspection, the demolition contractors had already dismantled the acid plant scrubbers and associated support towers and duct work.

This photo shows some of that material in the process of being cut-up into smaller pieces for future scrap metal recycling.

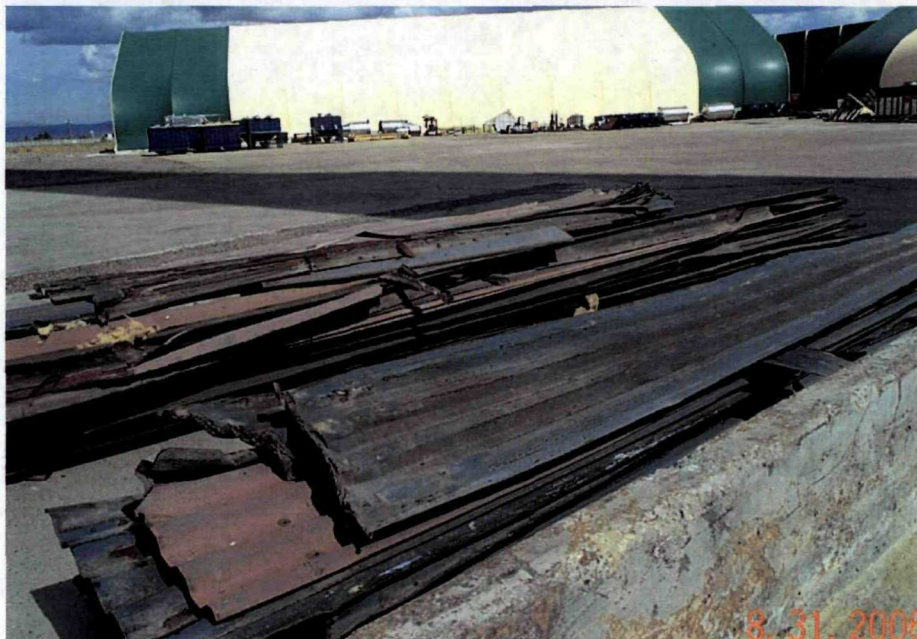
PHOTO #: ASARCO_06243-011

In addition, galbestos panels from the Mist Precipitator and Hot Cottrell buildings were being removed and stored at galbestos lay-down area to the east of the Bailey building. I noted that the paneling was not positioned at an angle so as to not allow standing water to collect on the surfaces on the panels. (See photos #010 and 011 in the attached photolog).

This photo shows the area and two piles of galbestos panels were being stored uncovered on site.

Note: In a letter to Asarco, panels from the Mist Precp and Hot Cottrell buildings can be stored here as long as they are placed on an angle so as to not allow standing water to collect on the suraces.

At the time of the inspection on Aug. 31, 2006, the panels were not placed on an angle.

ADDENDUM: On September 12, 2006, Mr. Amicucci and I went out to the area where the galbestos siding was stored. Looking through the fence, we noted that the galbestos panels were re-positioned at an angle so as to not allow standing water to collect on the surfaces on the panels.

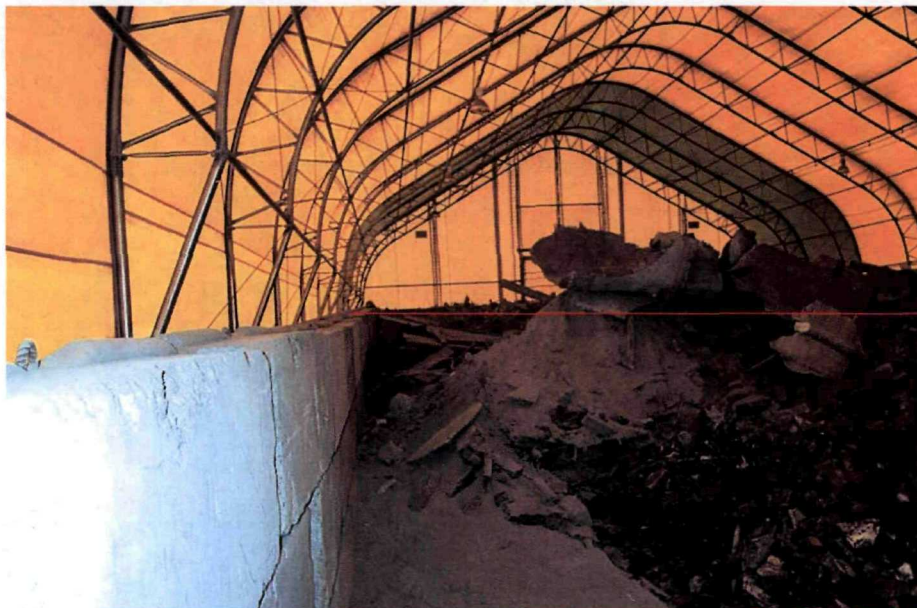
PHOTO #: ASARCO_06243-012

As we discussed, I observed a violation of the Administrative Rules of Montana (ARM) during my inspection. **ARM 17.53.602** adopts, by reference, the standards applicable to generators of hazardous waste as set forth in **40 CFR 265.1101(c)(1)(ii)** that states "Owners or operators of all containment buildings must maintain the level of the stored/treated hazardous waste within the containment walls of the unit so that the height of any containment wall is not exceeded".

During the inspection, I observed that waste contained in the Bailey building exceeded the height of the Lego blocks. (See photo #012 in the attached photolog).

Demolition debris from the Sinter plant, Dross plant and other process units are being stored in the Bailey Building pending disposal into the CAMU. At the time of the inspection, I noted that debris stacked in the building exceeded the height of the Lego blocks, which is in direct conflict with past guidance given by the Department to Asarco

representatives relative to how high the debris can be stored in this building. (See photo #012 in the attached photolog).

Material destined for disposal in the CAMU is stored in the Bailey Building.

Note that the material is stored higher than the retaining wall as indicated by the red line. This is a recurring problem as previously shown in photos taken on August 22, 2006.

Therefore, the Department of Environmental Quality (DEQ) requires that within 5 days of receipt of this letter, Asarco submit to this office written and photographic documentation to bring its hazardous waste storage practices in the Bailey building into compliance with the above citations. The documentation shall include, but not be limited to:

1. Photographic and written evidence that the waste material in the Bailey building has been properly stored within the containment (Lego block) wall.

He asked me at this time to talk to Envirocon's on-site demolition manager and explain to him the importance of storing the waste debris in the Bailey building only to the height of the Lego blocks. I proceeded to meet with Mr. Graham McMillian and explained to him the Department's position on storing waste in the Bailey building.

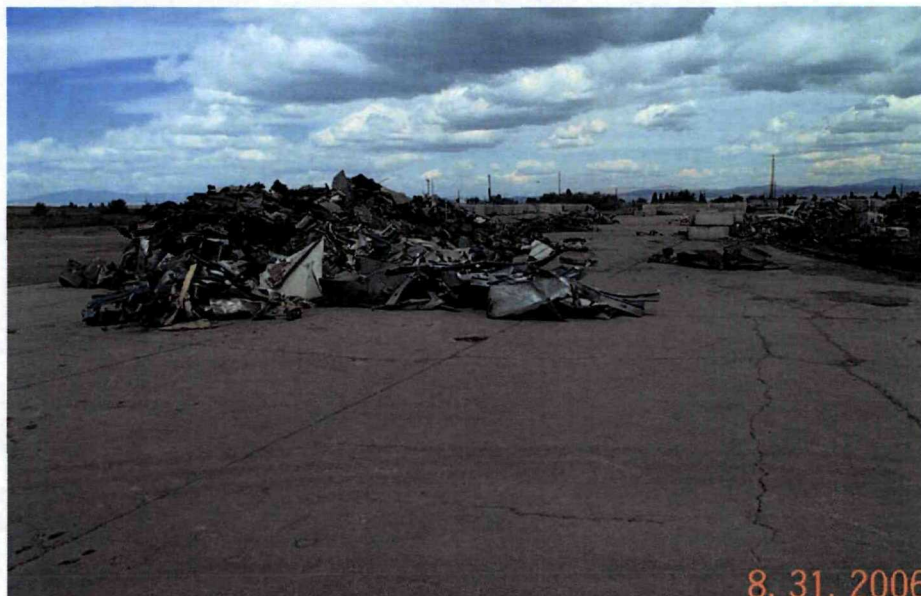
PHOTO #: ASARCO_06243-013

In addition, I inspected the Scrap metal lay-down area to the west of the Bailey building. The scrap metal came from the demolition of the Sinter plant, Dross plant and other process units. I observed several piles of scrap metal separated by concrete "jersey barriers" due to their recycling characteristics. The scrap metal was free of hazardous waste dust and ready for transport via railroad cars. I also saw three 20-yard roll-offs. Two of the roll-offs were empty. One held recyclable copper wire. (See photo #013 in the attached photolog).

Looking at the scrap metal lay-down area west of the Bailey building. The scrap metal is sized and sorted into various piles, which will eventually be loaded into railcars for metal recycling.

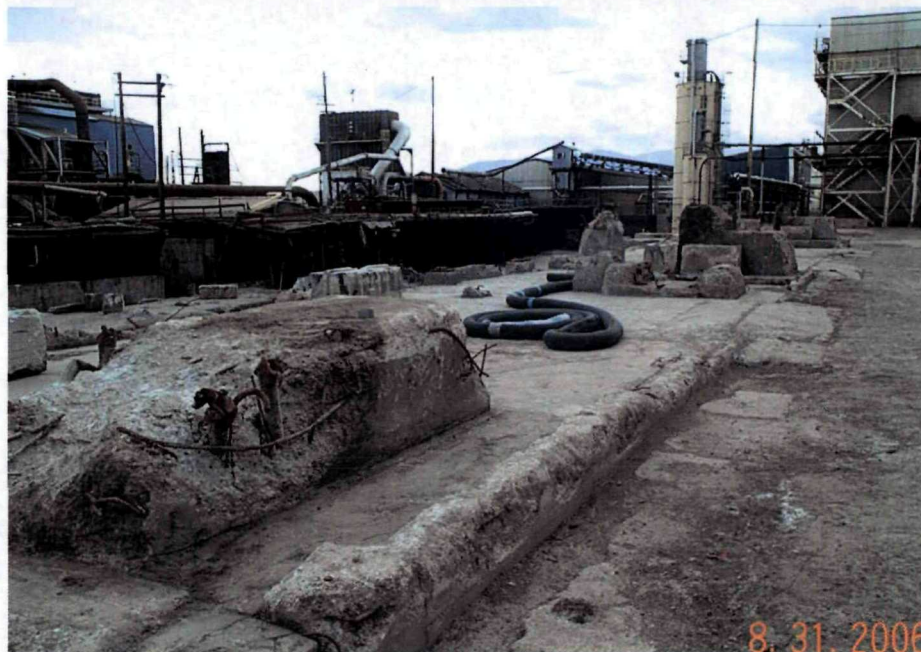
PHOTO #: ASARCO_06243-014

I observed that the decontamination and demolition of the Sinter Plant had been almost completed as outlined in Site Work Plan for this location. I took digital photographs to document the "footprint" of the Sinter Plant. Mr. Nickel pointed out to Ms. Jacobson and I that Asarco plans on leaving the concrete/steel abutments and adjacent asphalt road covering in place in the "footprint" to act as a permanent barrier. I noted that the area had recently been vacuumed and it appeared that the surface area contained no hazardous waste dust or residue. (See photos #014 and 023 in the attached photolog).

This photo shows the concrete and steel abutments still protruding above the floor at the Sinter Plant footprint.

The area was recently vacuumed to remove loose dust and other small debris.

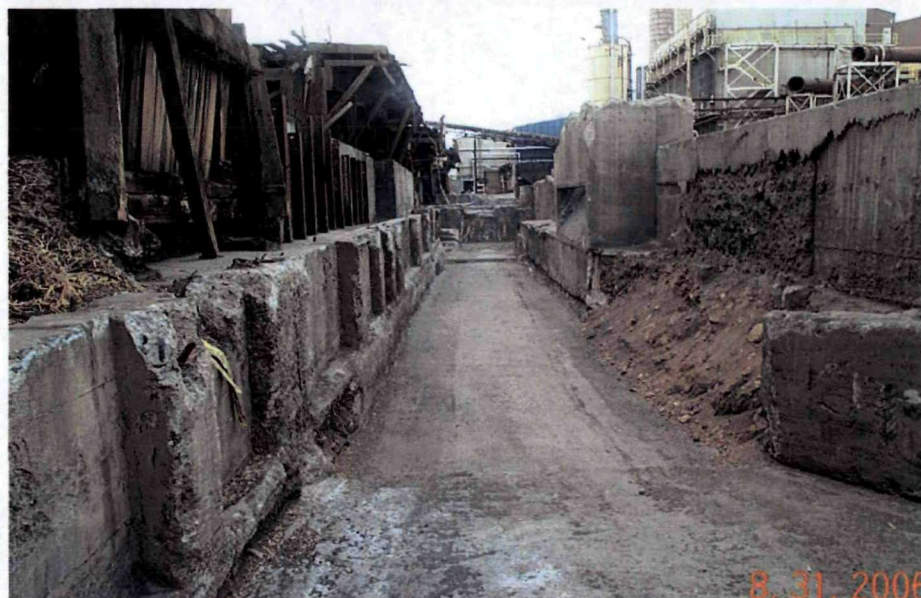
PHOTO #: ASARCO_06243-015

I walked down the length of the "Larry Pit" which runs parallel to the Sinter plant "footprint". I observed areas on the pit walls that were exposed to the elements or in need of further clean-up. Mr. Nickel told me that Asarco plans on covering up the exposed dirt, but for the most part, leave the "Larry Pit" as is to act as a permanent barrier. (See photos #015 and 016 in the attached photolog).

This photo shows the length and width of the "Larry Pit" at the former Sinter Plant.

Note that portions of the pit are exposed to the elements.

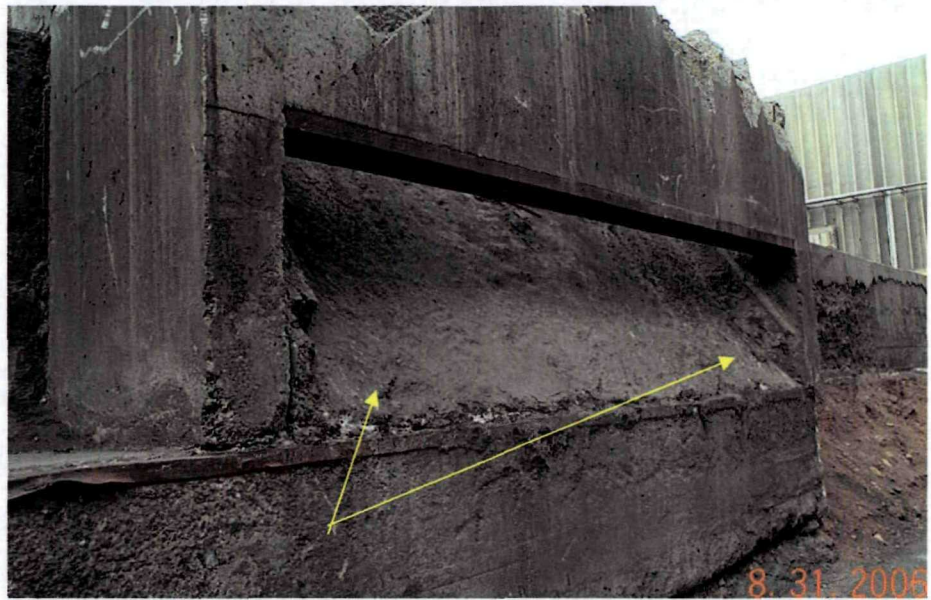
PHOTO #: ASARCO_06243-016

This photo shows a close-up of the south wall of the Larry Pit. At the time of the inspection loose waste material could be removed by hand indicated by the arrows.

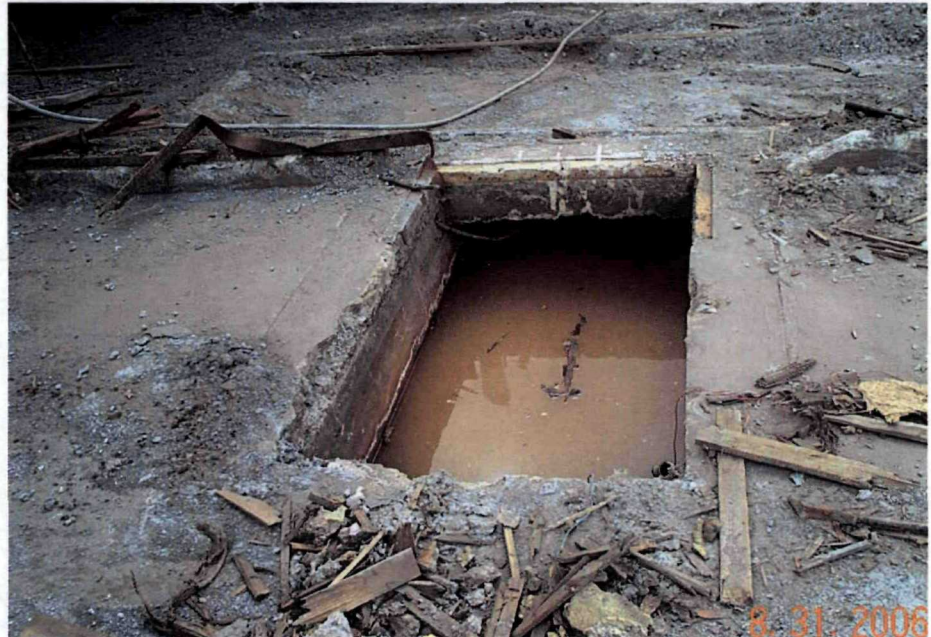
PHOTO #: ASARCO_06243-017

I also noted that several holes and a concrete trench still remain within the "footprint" (ie. elevator shaft, Sinter plant basement filled with water, sump pit and two other openings) that could allow storm water to seep into the soil. Mr. Nickel told me that Asarco wanted to fill these openings with fumed slag to prevent stormwater seepage in the near future. (See photos #017, 018, 019, 020, 021, 022 and #024 in the attached photolog).

Looking at standing water in the former basement of the Sinter Plant.

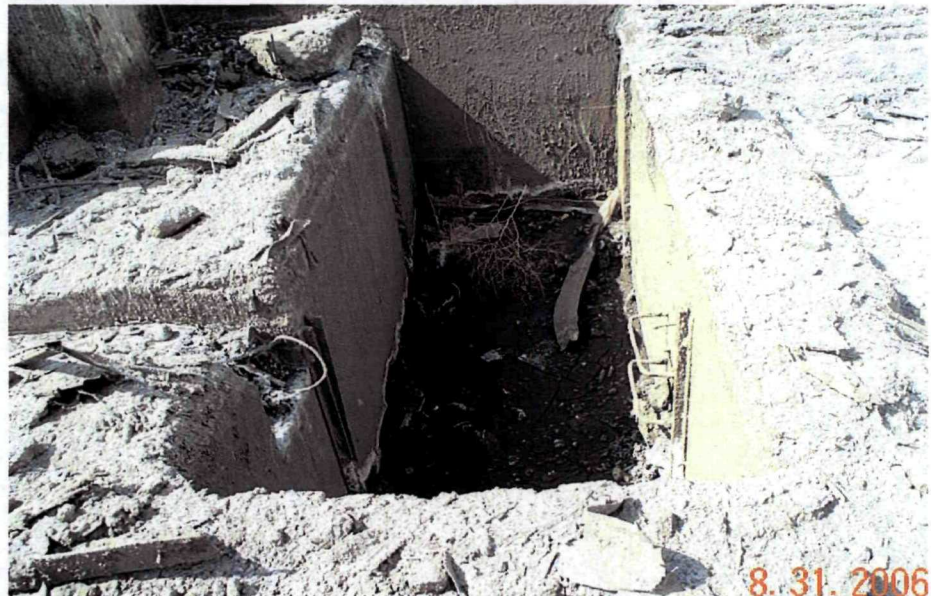
PHOTO #: ASARCO_06243-018

Next to the basement shown in photo #017 is another hole that appears dry at the time of the inspection.

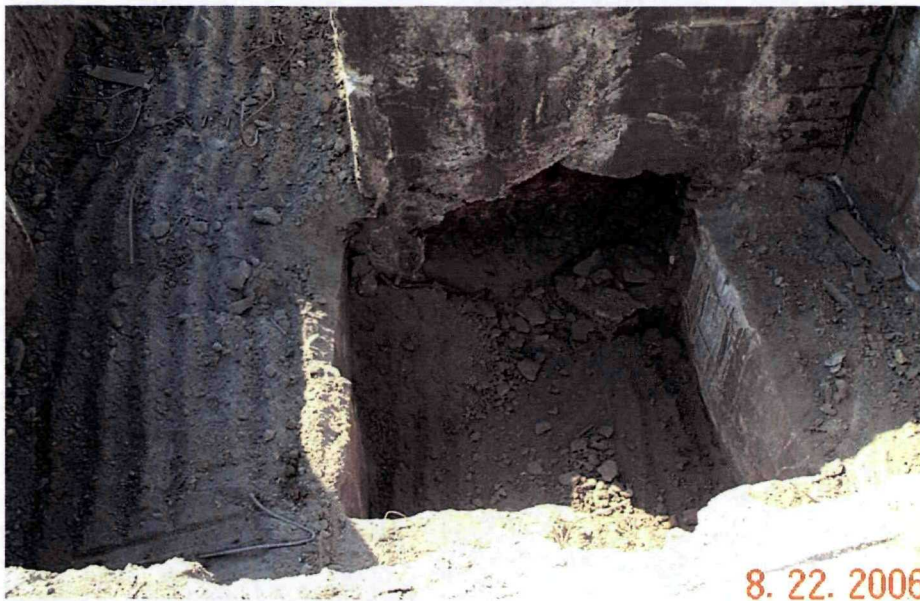
PHOTO #: ASARCO_06243-019

Looking at an elevator shaft that was part of the Sinter Plant on the east end of the footprint.

The open shaft still contains waste material and allows storm water to collect on the bottom of the hole.

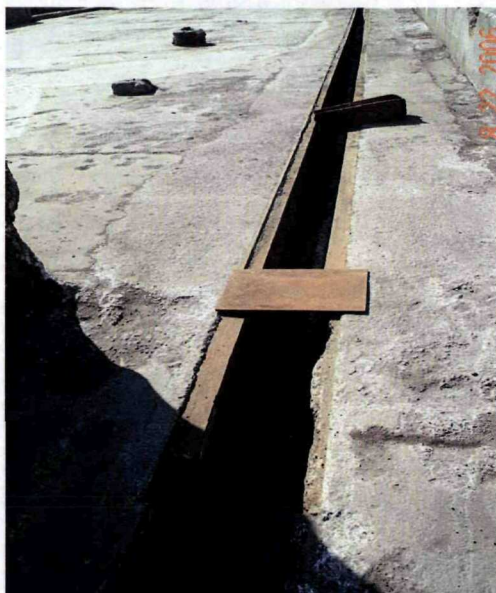
PHOTO #: ASARCO_06243-020

Running the length of the Sinter Plant footprint is this long trench.

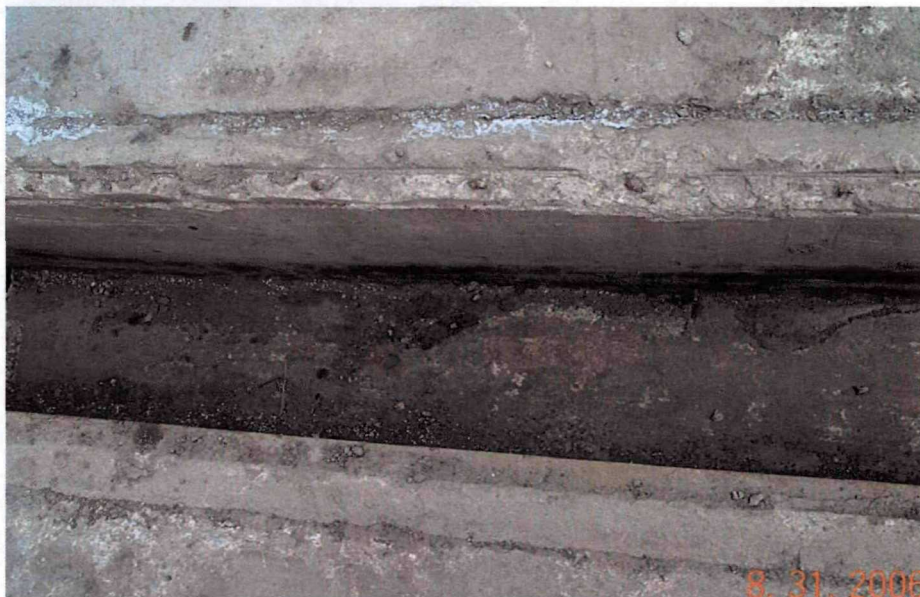
PHOTO #: ASARCO_06243-021

Looking at the sides and bottom of the trench as described in the previous photo. It appears that the trench bottom is made of concrete.

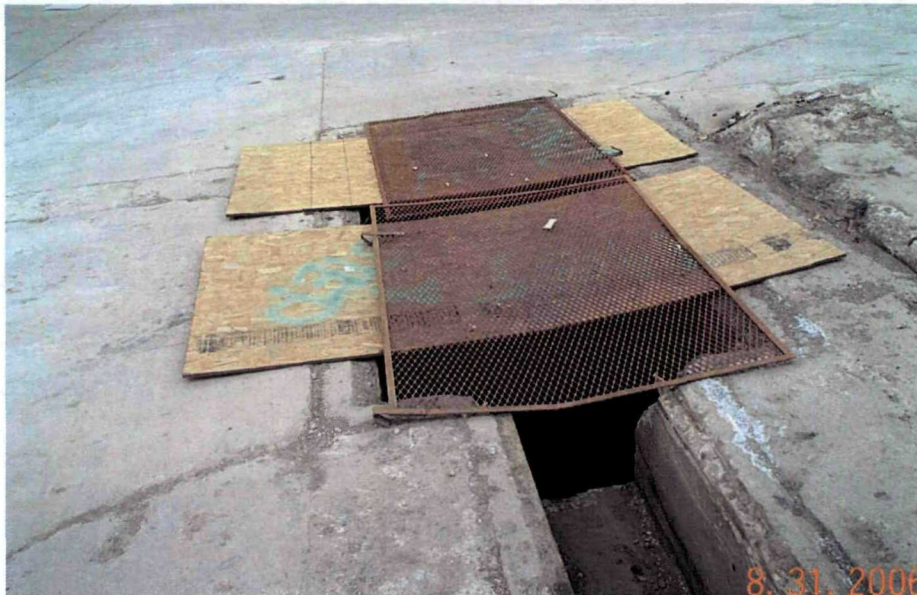
PHOTO #: ASARCO_06243-022

Looking at an open pit on the west end of the Sinter Plant footprint that once held run-off water and material from the process unit. At the time of the inspection the pit was dry.

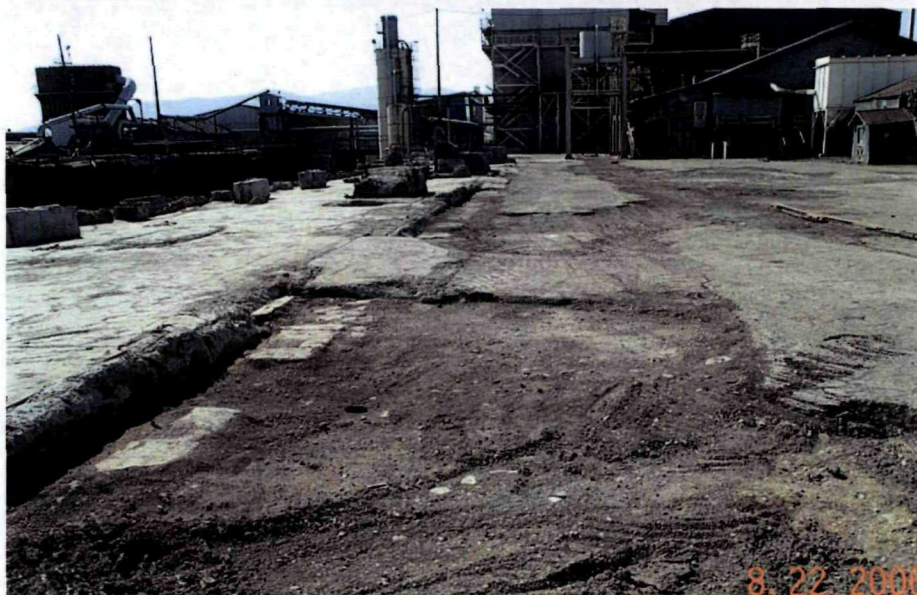
PHOTO #: ASARCO_06243-023

The photo shows the concrete top of the Sinter Plant footprint and asphalt covering to the south of the footprint.

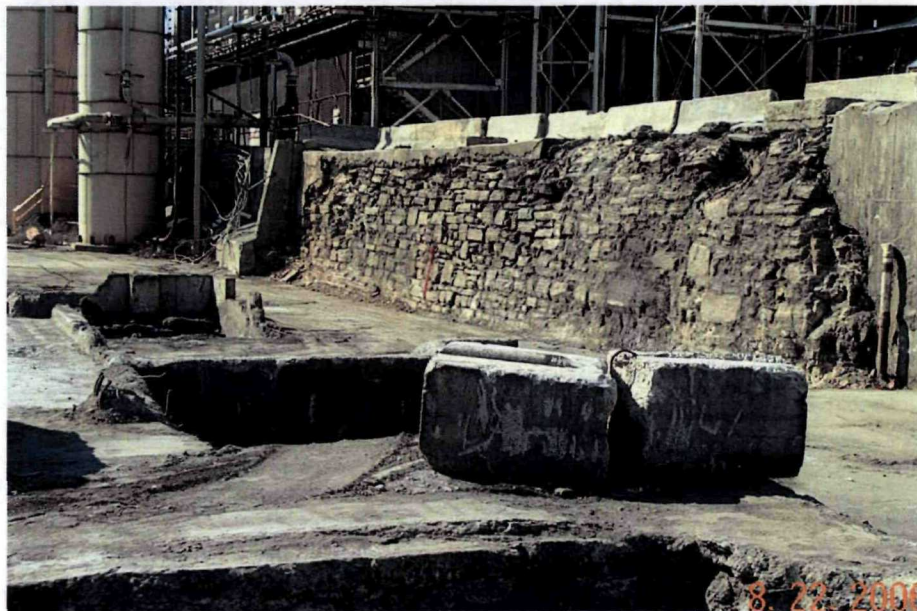
PHOTO #: ASARCO_06243-024

Looking at another view of the former elevator shaft and other openings in the floor at the east end of the Sinter plant footprint.
